Exhibit 57

Public Utilities Commission

CITATION

Enclosure 2 – PG&E Moss Landing Tower Collapse Direct Cause Analysis

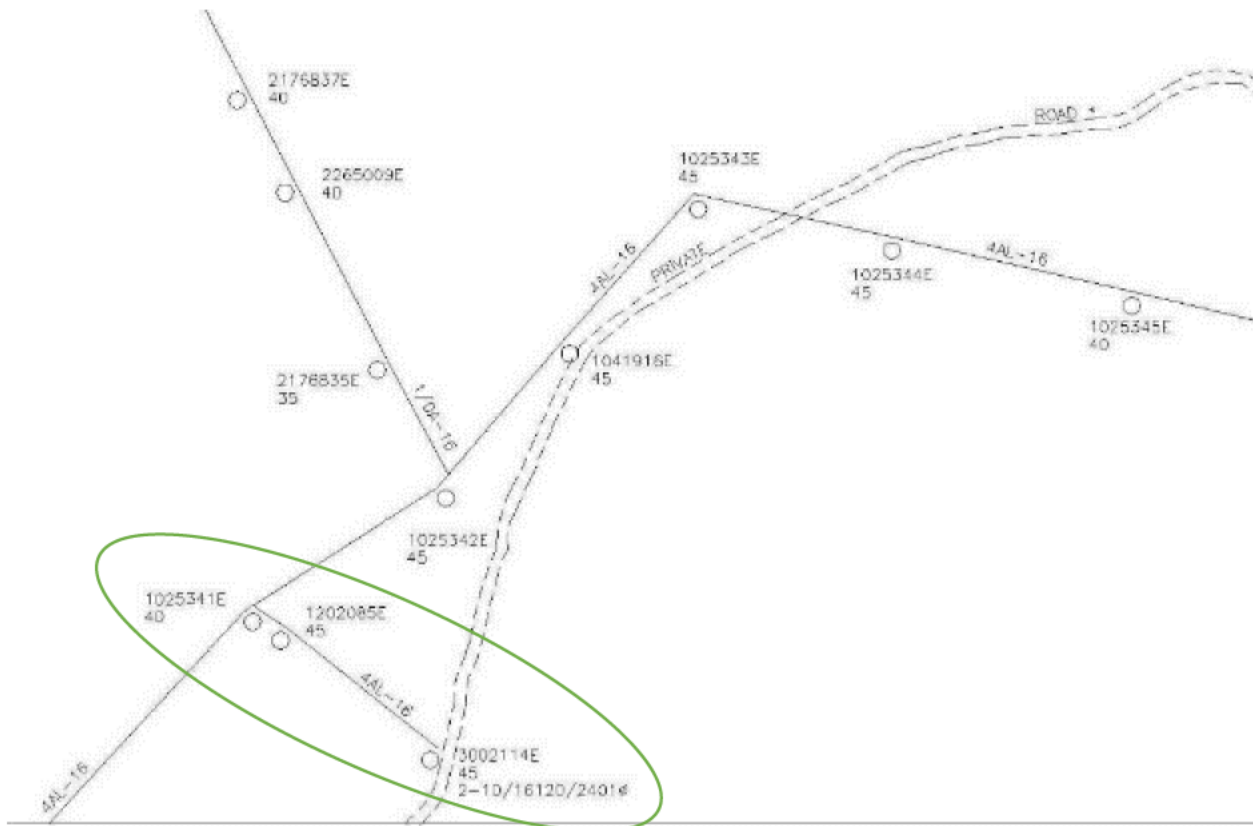
Figure 6: FIM Anlauf Canyon area of interest⁶¹

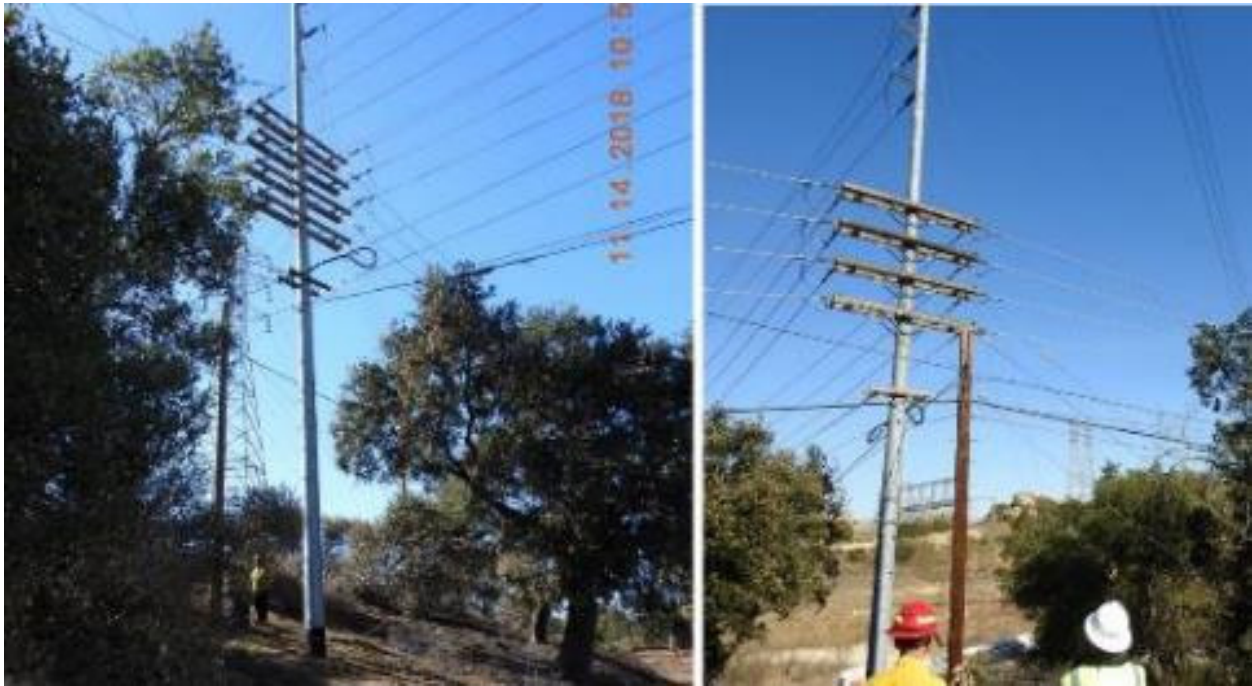
The facilities involved at Site 2 included pole number 4534353E (hereafter referred to as “the Steel Pole”) and pole number 984161E,² a stubbed wooden pole (hereafter “the Stubbed Pole”), located about thirty feet south of the Steel Pole. See Figure 2.

Figure 2: Site 2 as viewed from the north (left) and from the south (right).³

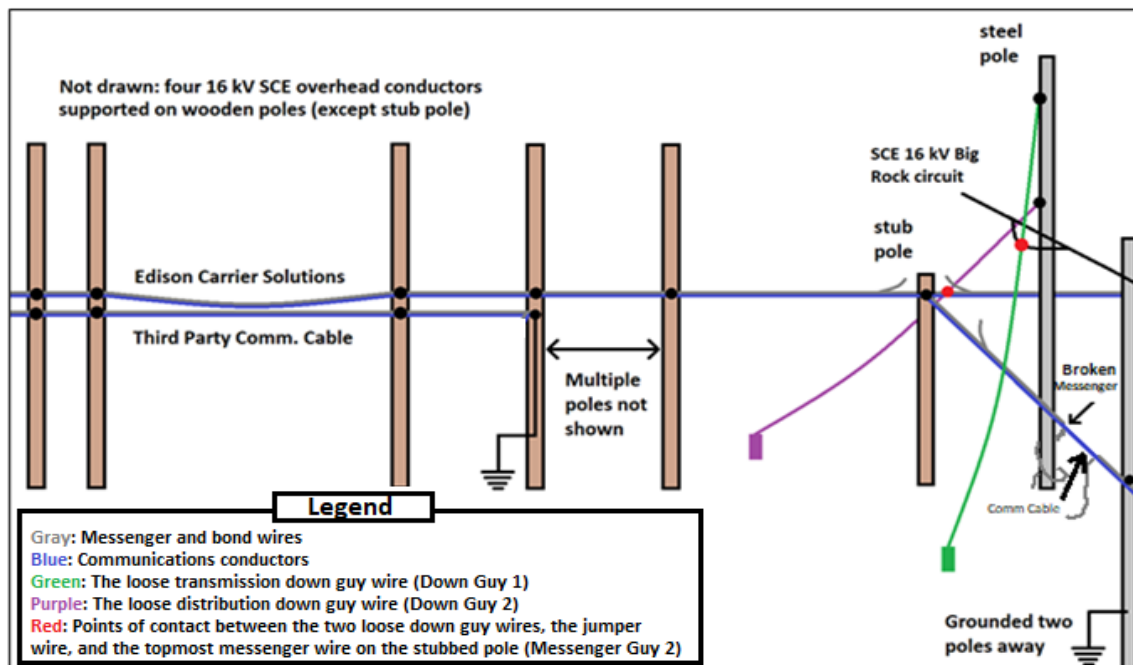
Figure 8: Diagram of the facilities at Site 1 and Site 2. Site 1 is on the left, and Site 2 is on the right.

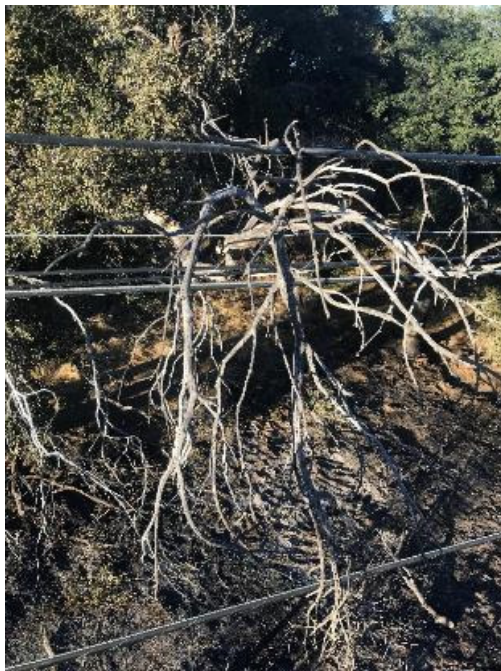
Figure 23: Another view of the overgrown tree branches pressing the communications facilities together. Viewed from an elevated position in the south.³⁴

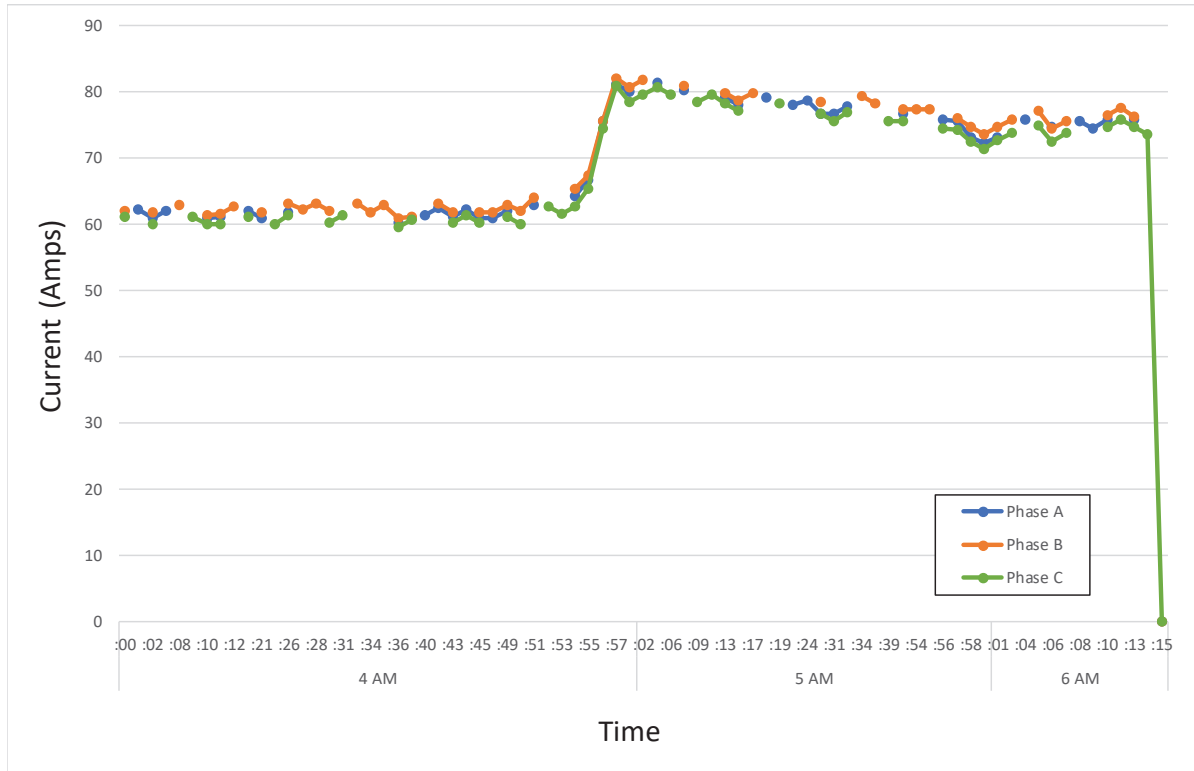
- At approximately 0457 hours on November 8, 2018, the Supervisory Control and Data Acquisition (SCADA) data from the Palermo Substation¹⁵ showed the current in the line reached approximately 80 Amps¹⁶ as shown in Figure 1.

Figure 1: Chart of SCADA data recorded at Circuit Breaker 152 on the Caribou-Palermo 115 kV Transmission Line just before the incident.⁷⁷

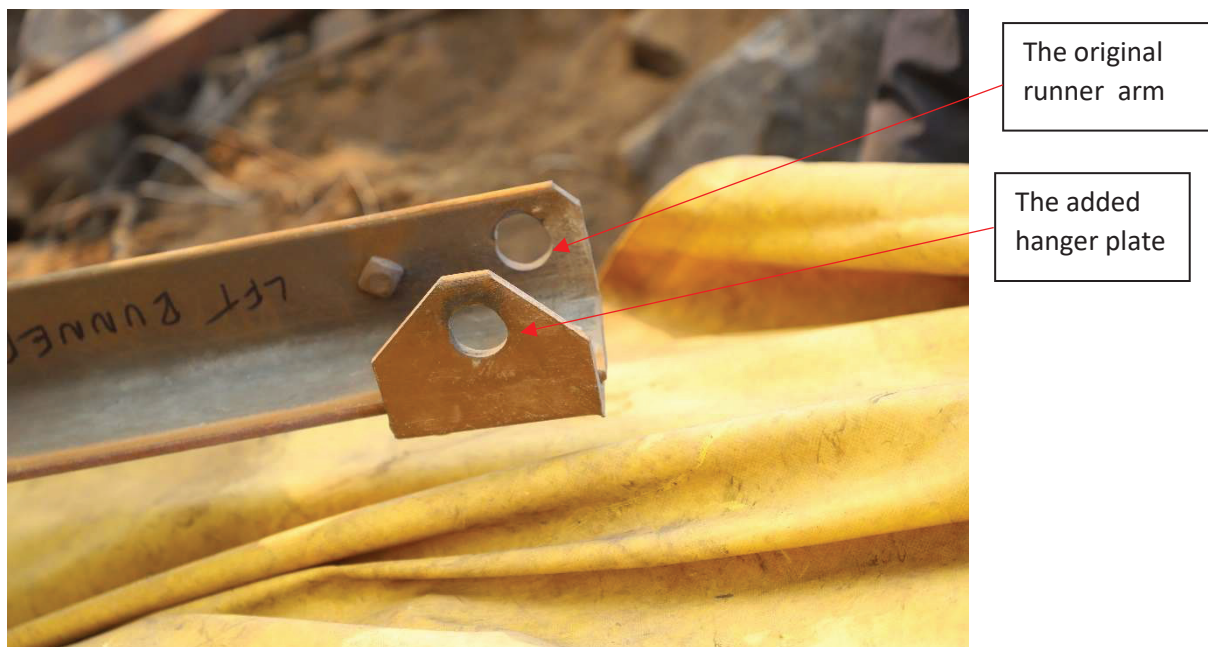
elongated holes in Figure 6 and Figure 7. For reference, Figure 8 shows a typical location of runner arms on transmission towers that have them.

Figure 6. The left runner arm and the added hanger plate from the Incident Tower.⁸²

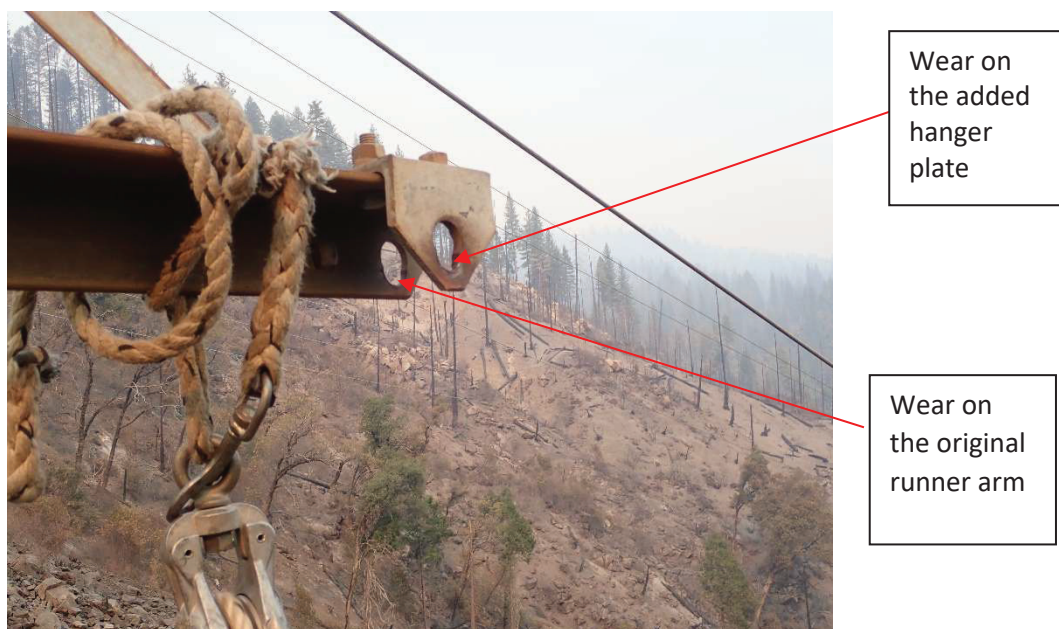
Figure 7. The right runner arm and the added hanger plate from the Incident Tower prior to removal from the tower for evidence. Photo provided by PG&E.⁸³

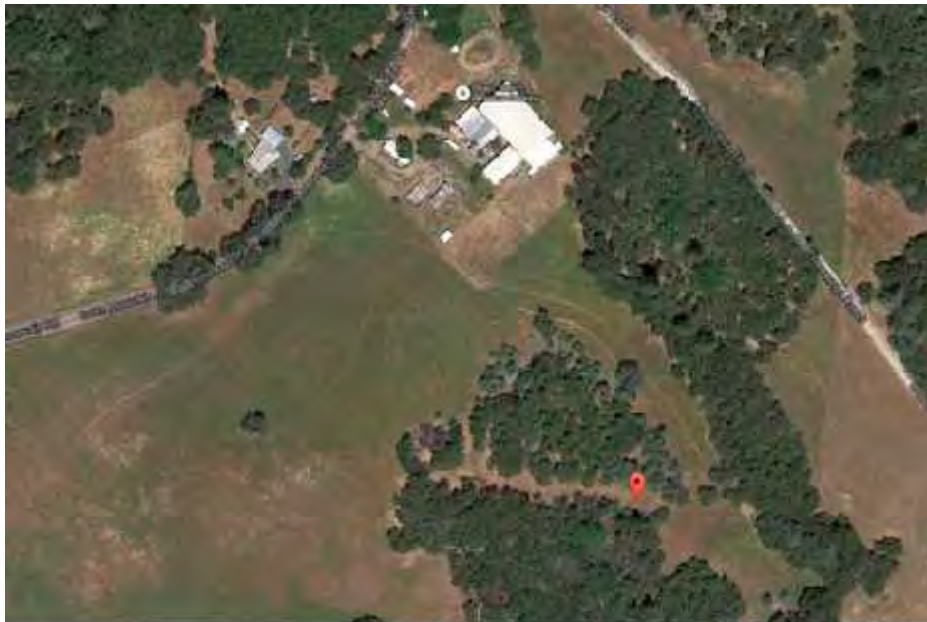
On September 9, 2015 at approximately 1446 hours, a 44-foot gray pine tree contacted an overhead conductor of PG&E's Electra 1101 12 kV circuit located in the vicinity of the residence property at 17704 Butte Mountain Road in the city of Jackson in Amador County (see figure 1), starting the "Butte Fire". The fire burned 70,868 acres, destroyed 921 structures (549 homes, 268 outbuildings, and 4 commercial properties), damaged 44 structures, and resulted in two civilian "indirect" fatalities and one injury. Both death victims were residents of Calaveras County who refused to evacuate the area as recommended by local authorities. The coroner's reports indicated that the cause of death for both victims was "consumption by fire (residential conflagration)". The fire caused power interruptions to 3644 customers for 16,651,071 customer minutes, 6377 customers for 10,053,920 customer minutes and 4246 customers for 23,519,468 customer minutes. The 12 kV conductor did not fail and fall to the ground.

Figure 1: Ignition point/location

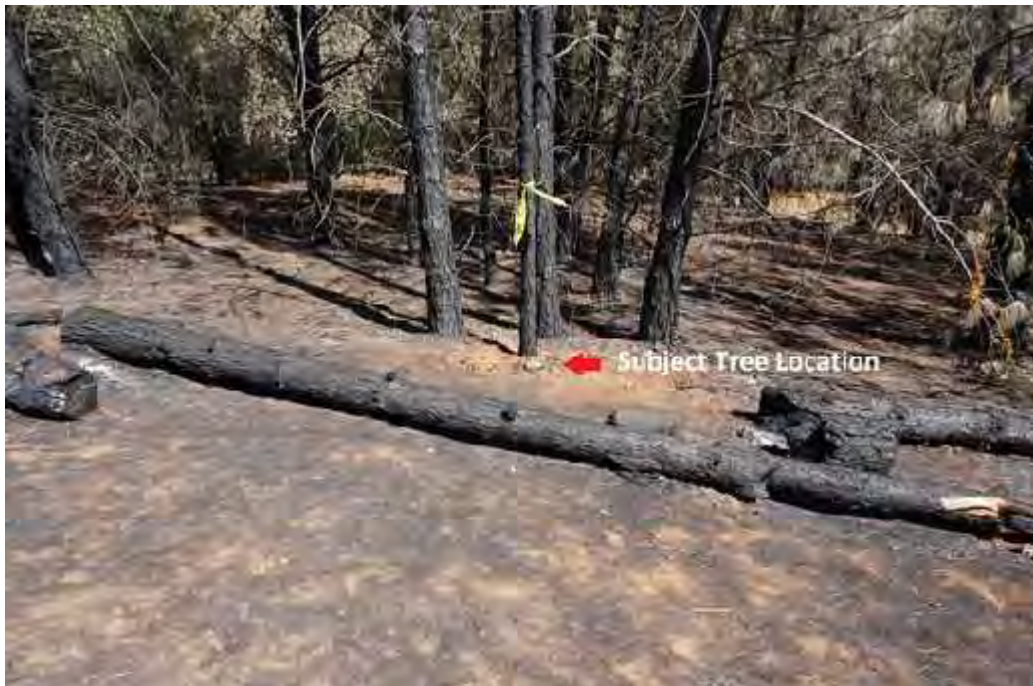
On September 18, 2015, SED met with CAL FIRE Battalion Chief Gianni Muschetto, CAL FIRE Attorney David Wiseman, [REDACTED] and [REDACTED] of PG&E at the incident location. SED observed that the subject tree had been removed, and a section of the 12 kV conductor had been replaced. Although the 12 kV conductor did not fail and fall to the ground, CAL FIRE requested that PG&E cut and remove the section of the conductor that contacted the tree as part of CAL FIRE's evidence collection; CAL FIRE also cut down and retained the tree as evidence (see figures 2 and 3).

Figure 2 – Subject Tree Stump

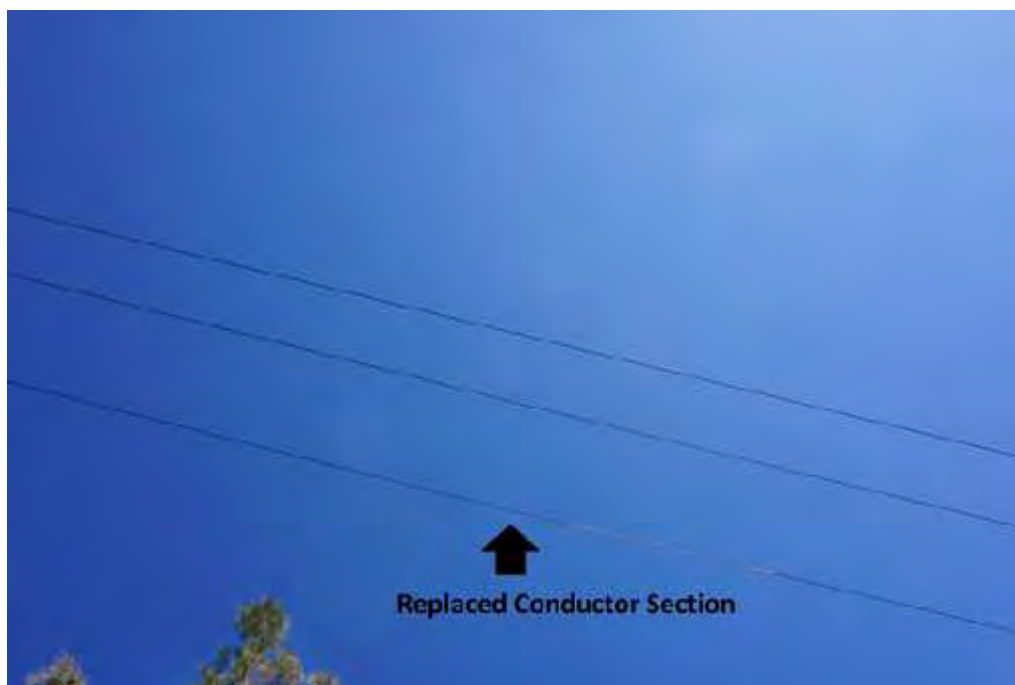
Figure 3 – Replaced Conductor Section

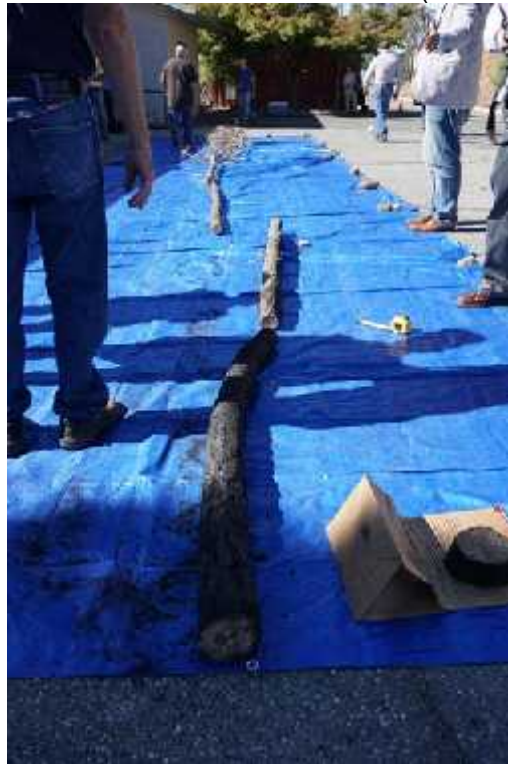
On September 22, 2015, SED staff examined the subject tree and conductor at CAL FIRE's Auburn Headquarters; SED staff observed that the subject tree was cut into sections and also noticed discoloration on the section of the conductor that had been removed (see figures 4 and 5).

Figure 5 – Sections of the tree
